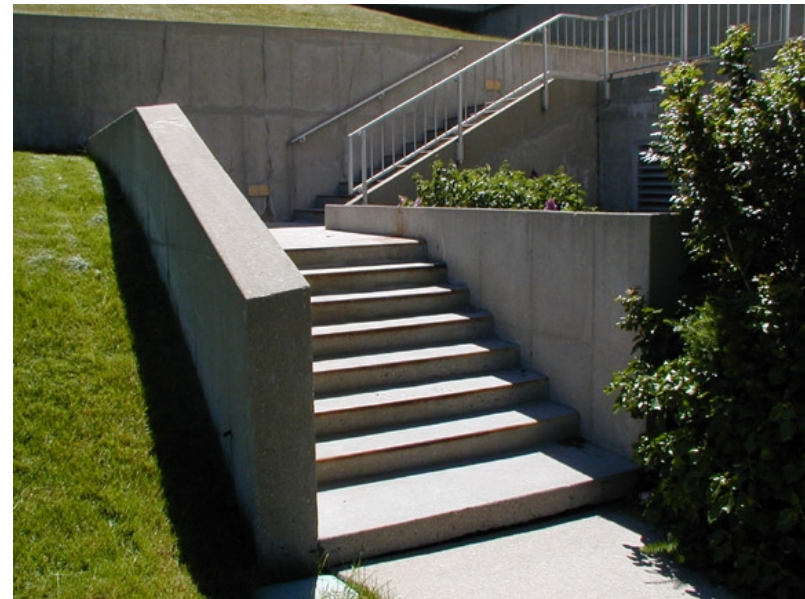
**ID**    **1**

**NE corner of State Office Building, looking south**

Stairs down to courtyard area

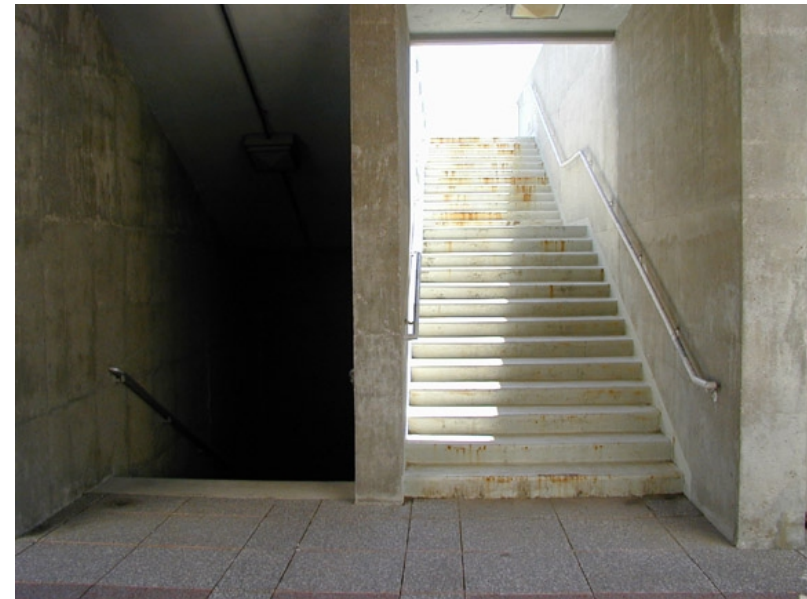
**ID**    **2**

**Category:**                    **Stairs**  
**Location:**                   **East of State Office Building, looking east**

*Satisfactory:*                ☐  
*Damaged:*                   ☒  
*Condition Code:*           ST

*Condition Description:*   Significant Staining, needs cleaning;  
   may indicate rusted connector

*Comments:*                   Rusted areas on edges of steps

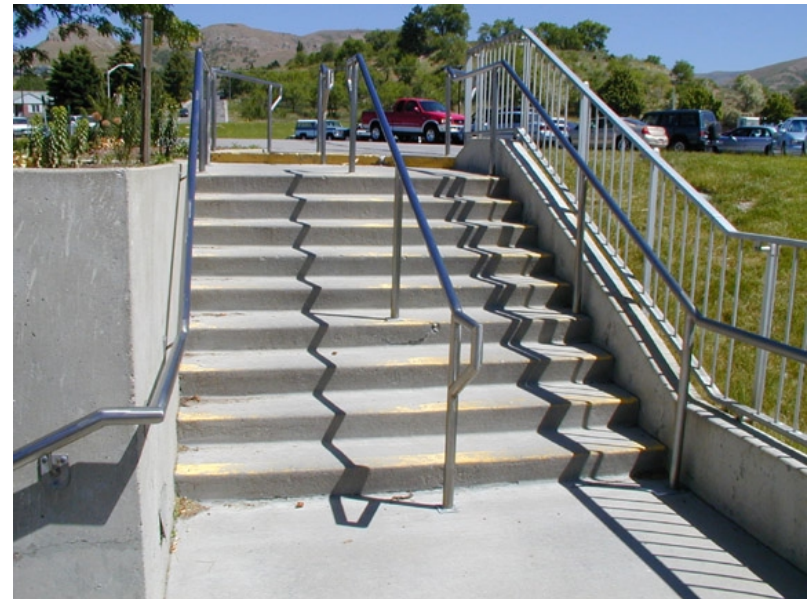
**ID**    **3**

Stairs to Middle East parking area.

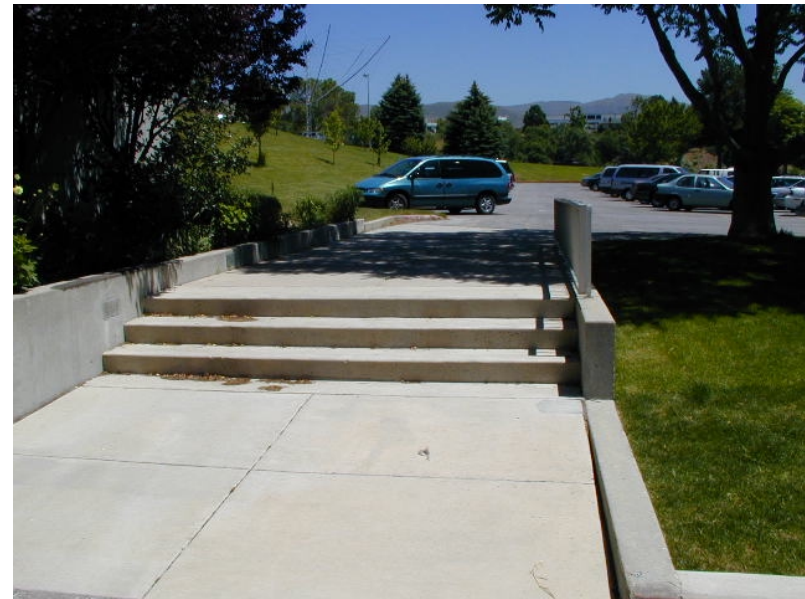
**ID**    **4**

Stairs to Middle East parking area.

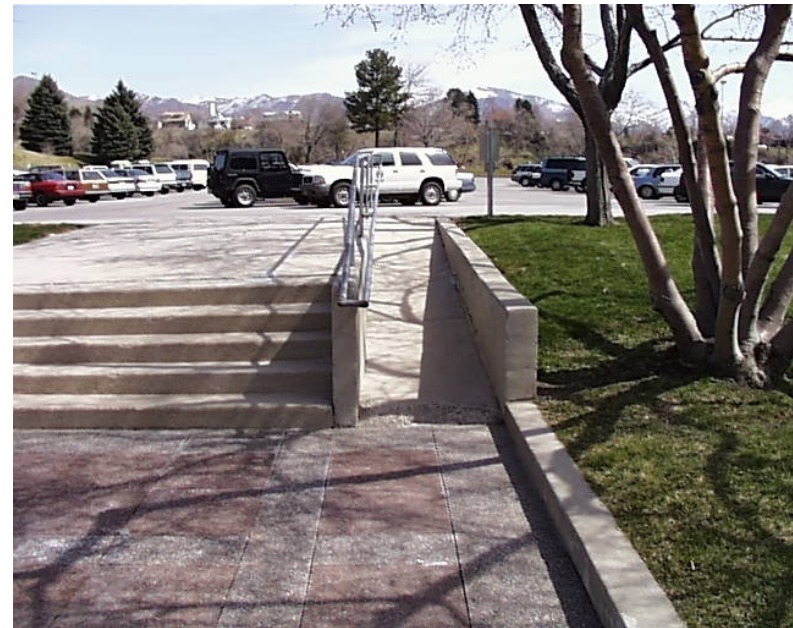
ID 5

Ramp not handicap accessible per sign located at top of ramp.

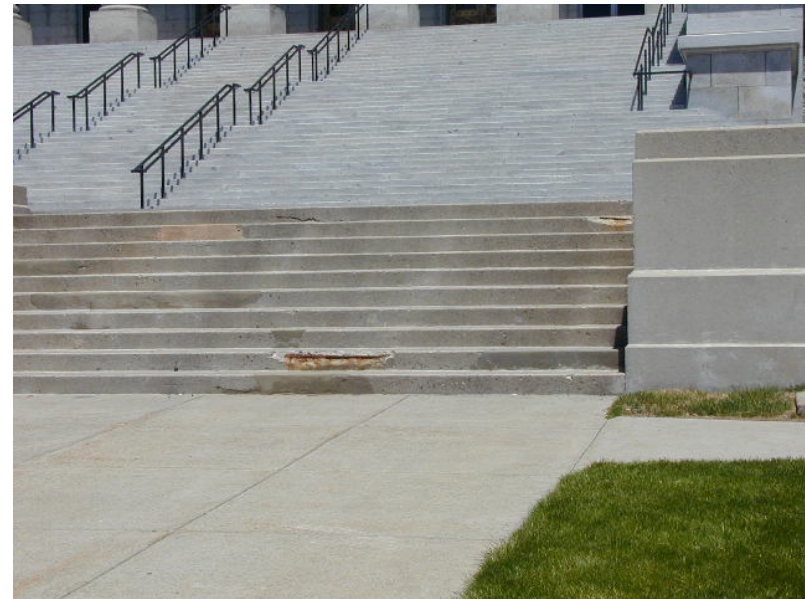
**ID**    **10**

**State Capitol, front stairs**

CO

Cracked, spalled, damaged concrete,  
needs repair or replacement

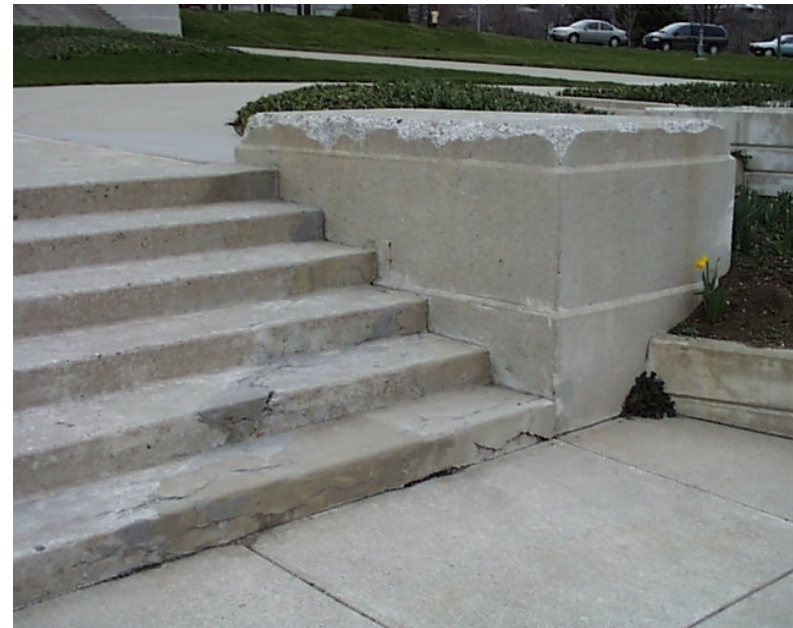
**ID**    **11**

**State Capitol, front steps**

CO

*Condition Description:* Cracked, spalled, damaged concrete,  
needs repair or replacement

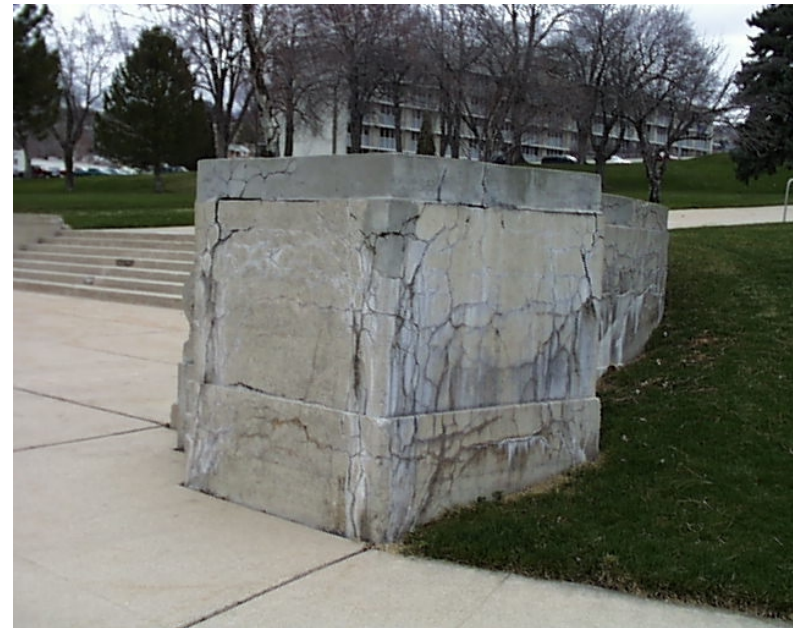
ID 15

### West entrance to State Capitol

CO

Cracked, spalled, damaged concrete,  
needs repair or replacement

See next photo for side view.

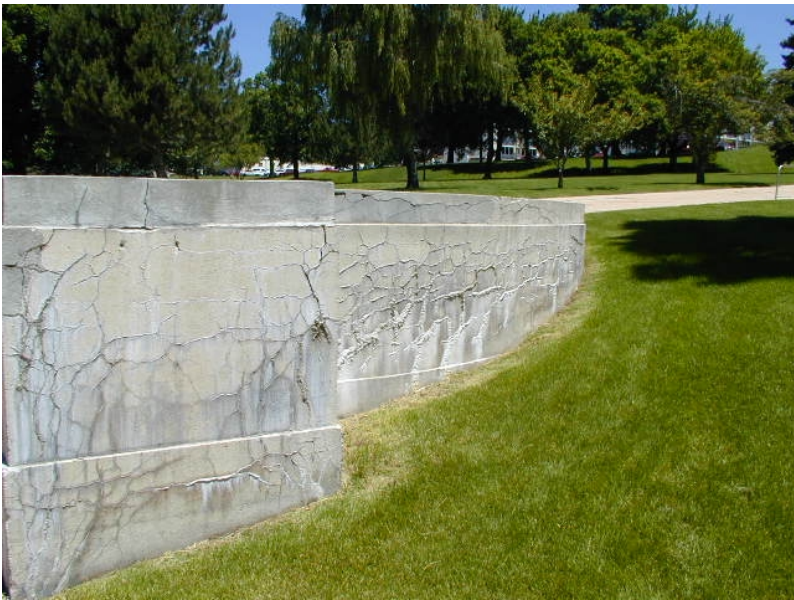
<b>ID</b>	<b>16</b>
-----------	-----------

<b>Category:</b>	<b>Stair feature</b>
<b>Location:</b>	<b>West entrance at Columbus Street</b>
<i>Satisfactory:</i>	<input type="checkbox"/>
<i>Damaged:</i>	<input checked="" type="checkbox"/>
<i>Condition Code:</i>	CO
<i>Condition Description:</i>	Cracked, spalled, damaged concrete, needs repair or replacement
<i>Comments:</i>

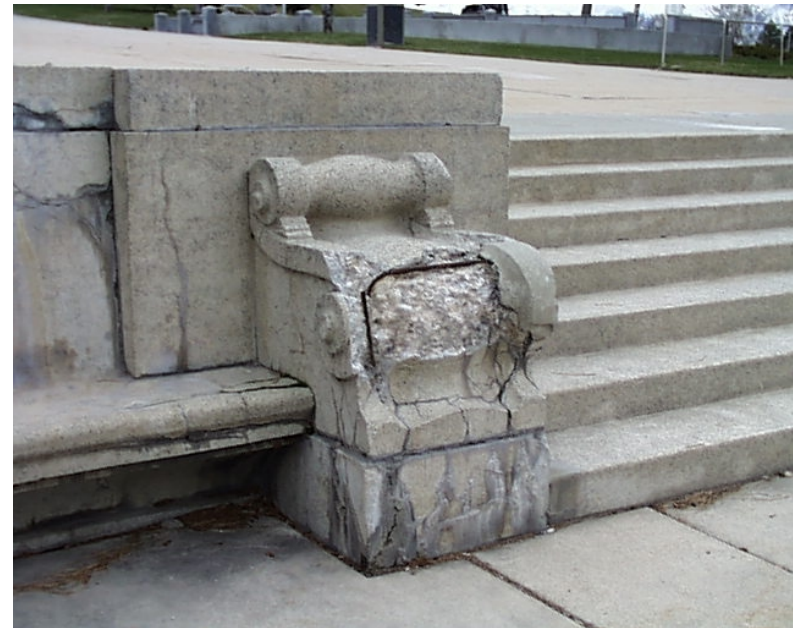
**ID** 17

**West entrance at Columbus Street**

CO

*Condition Description:* Cracked, spalled, damaged concrete,  
needs repair or replacement

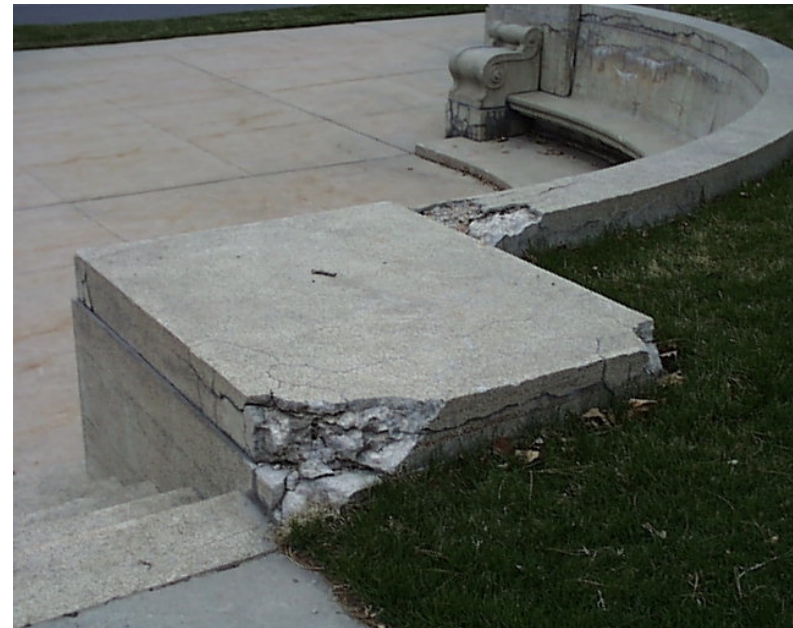
ID 18

**Category:** Stair feature  
**Location:** West entrance at Columbus Street

CO

*Condition Description:* Cracked, spalled, damaged concrete,  
needs repair or replacement

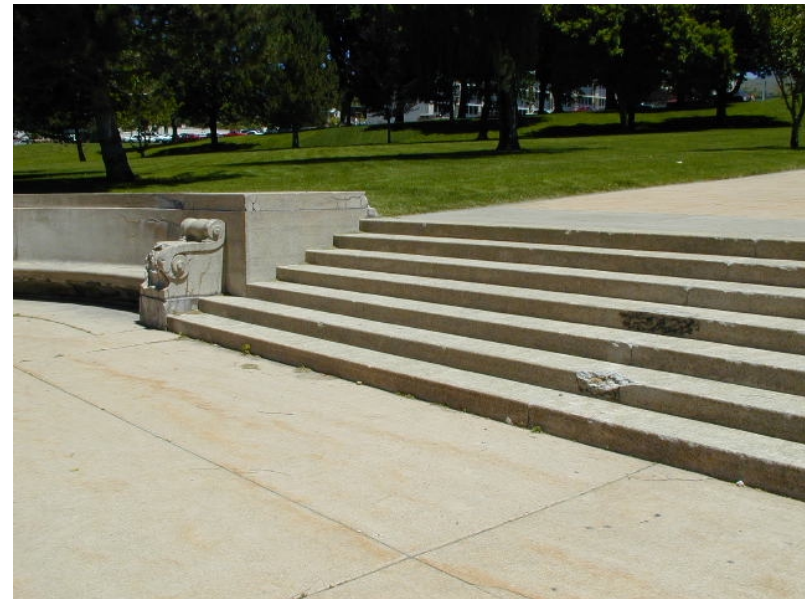
**ID**    **19**

**West entrance along Columbus Street**

CO

*Condition Description:* Cracked, spalled, damaged concrete,  
needs repair or replacement

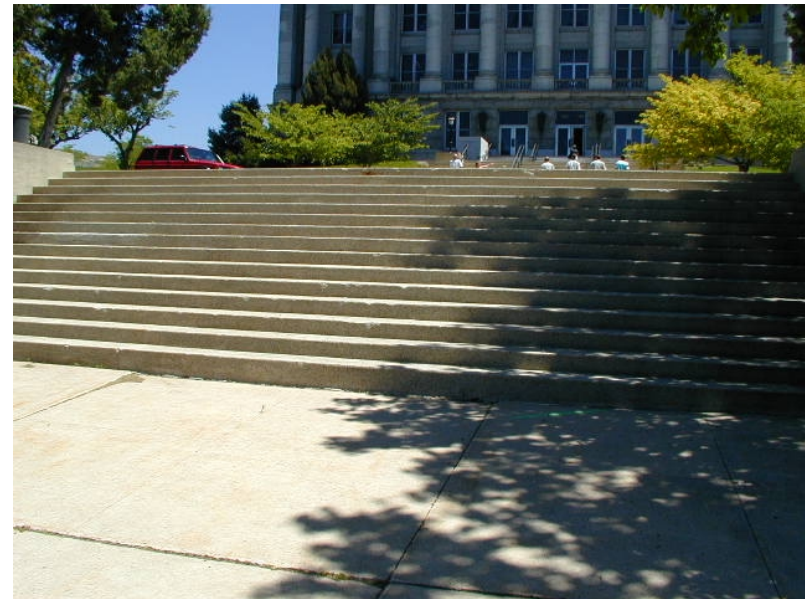
ID 21

**Category:** Stairs  
**Location:** State Capitol, west entrance

*Condition Code:* CO

*Condition Description:* Cracked, spalled, damaged concrete,  
needs repair or replacement

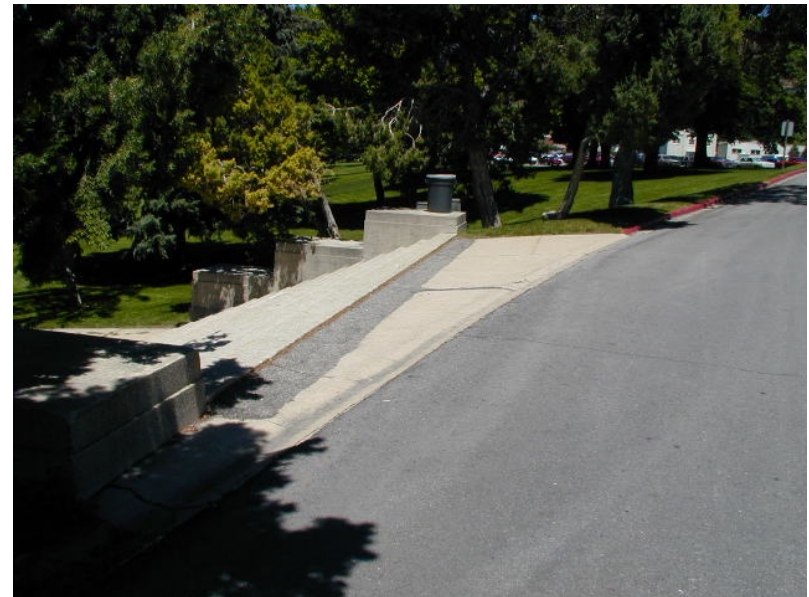
**ID**    **22**

**Category:**                    **Stairs**  
**Location:**                   **State Capitol, west entrance**

*Condition Code:*           **O**

*Comments:*                   Uneven transistion from steps to Capitol;  
pedestrian traffic must step across gutter and  
patched pavement to reach stairs.

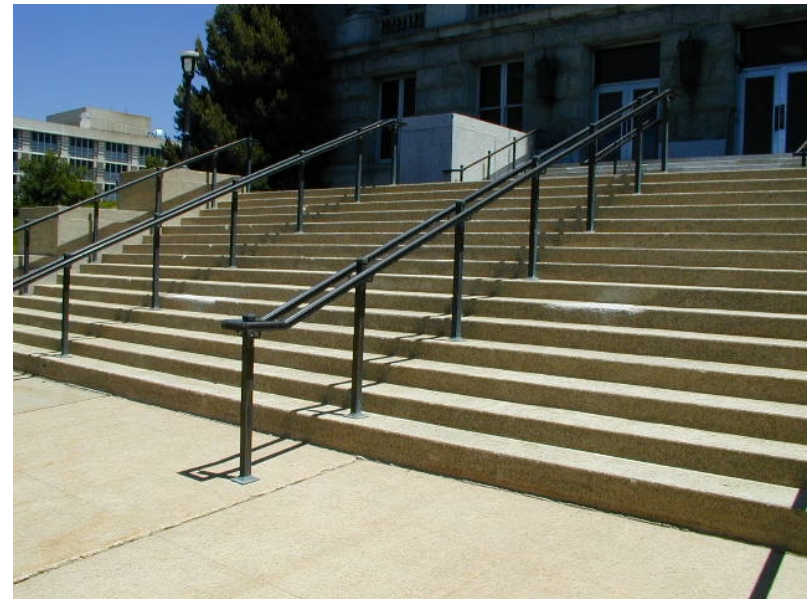
ID 23

Edges of steps show a few minor chips/spalling on the concrete.

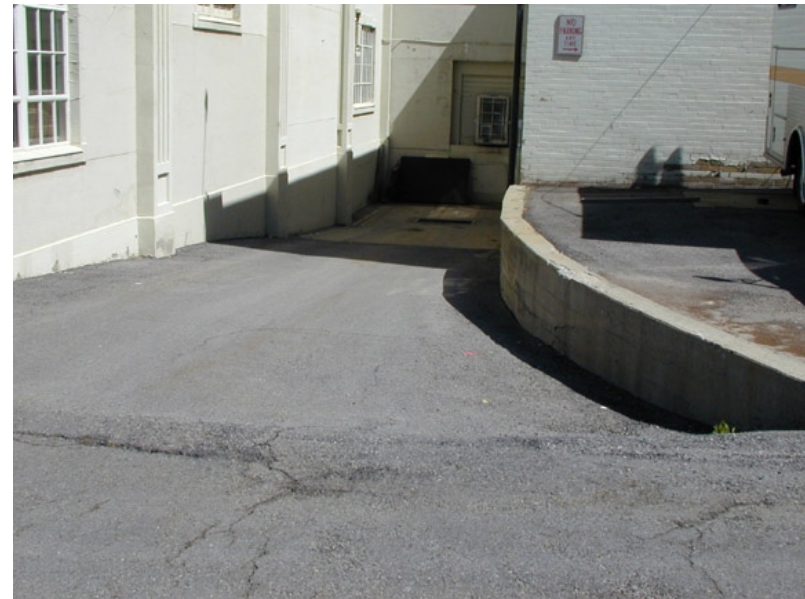
**ID**    **31**

**Archves Building, east of and adjacent to**

Large drop at entrance to ramp is difficult to see on the asphalt.

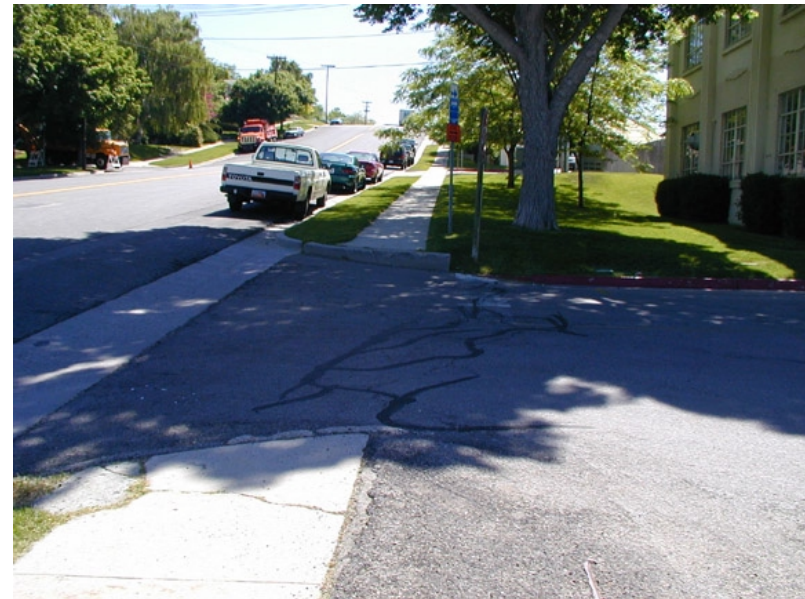
**ID**    **34**

**500 North behind Archives Building**

A few cracks from settling. No handicap ramp,  
no handicap access per sign.

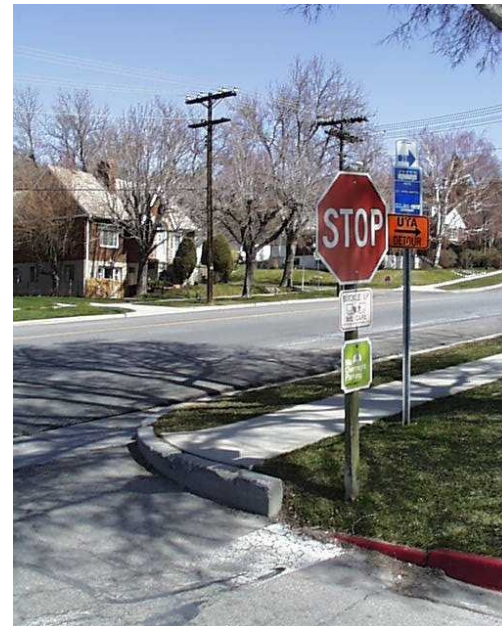
**ID**    **35**

Good condition, steep curb. No handicap access along this sidewalk.

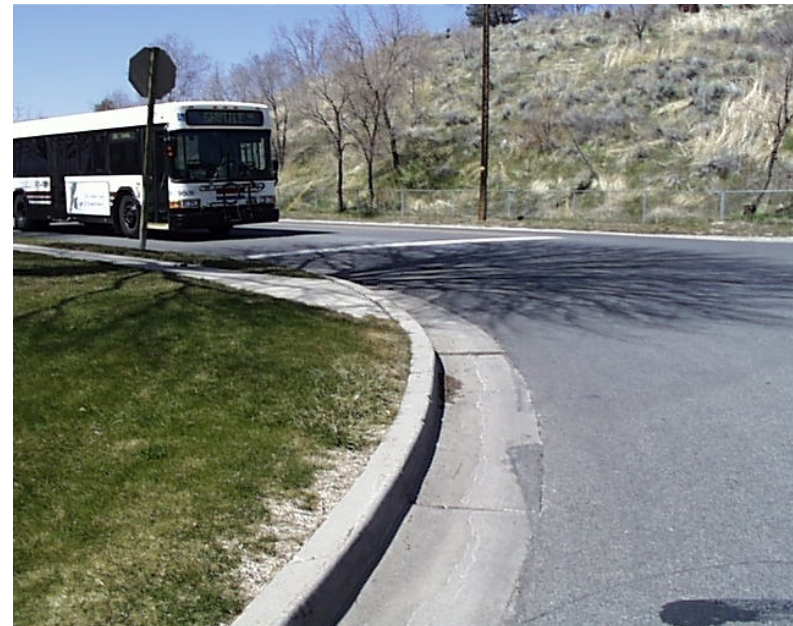
**ID**    **38**

No handicap ramp. End of sidewalk - none along East Capitol.

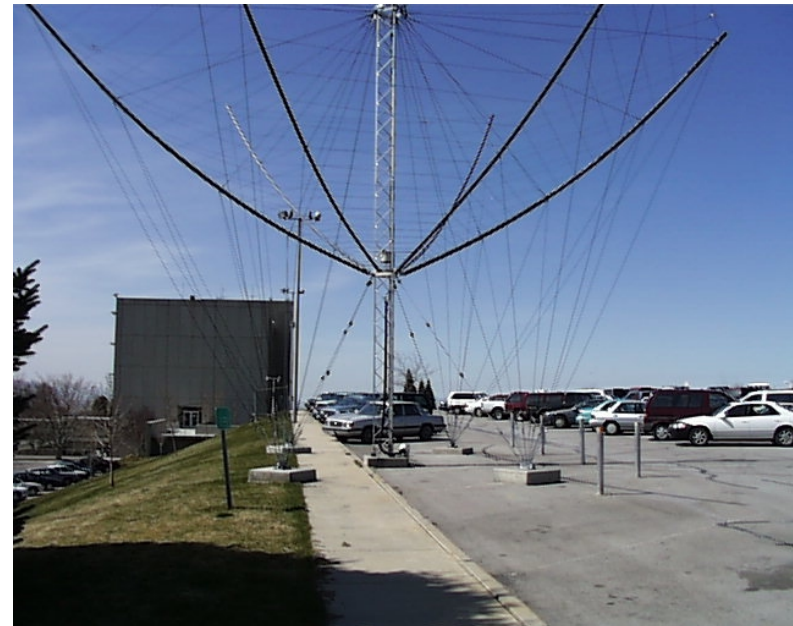
**ID**    **39**

**Northeast parking area, east of State Office Bldg.**

O

Sidewalk obstructed by large antennae. Cars also extend onto sidewalk as there is no curb to keep cars back.

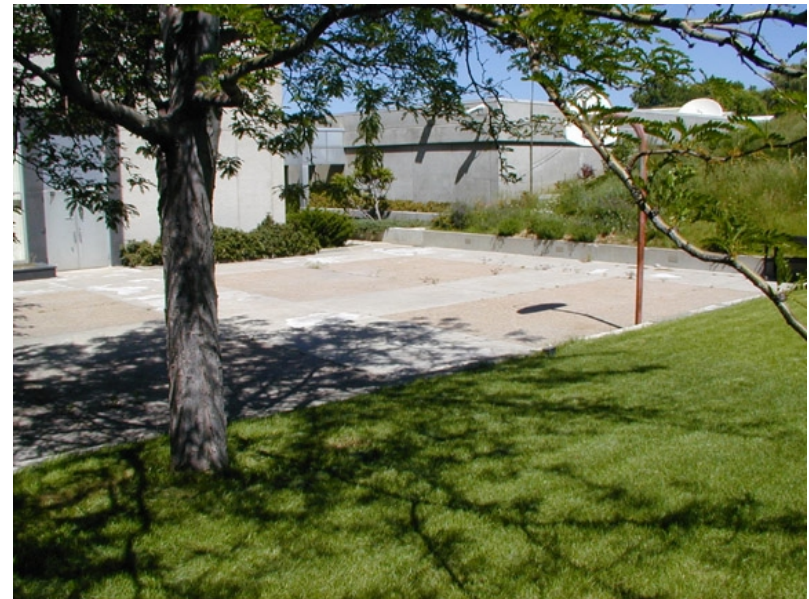
ID 42

**NE courtyard of State Office Building**

CO

Cracked, spalled, damaged concrete,  
needs repair or replacement

Uneven patchwork, severe cracking and erosion in corner.

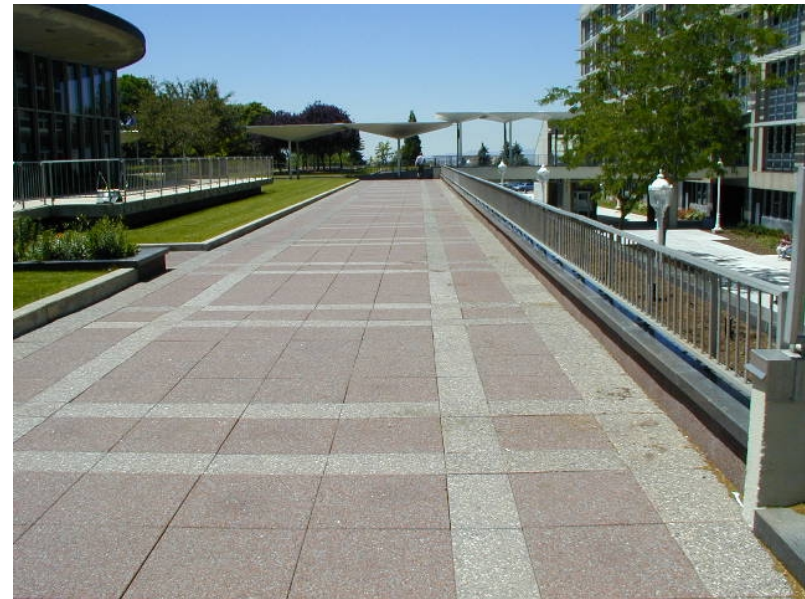
ID 43

Note that grout between bricks was missing in some locations.

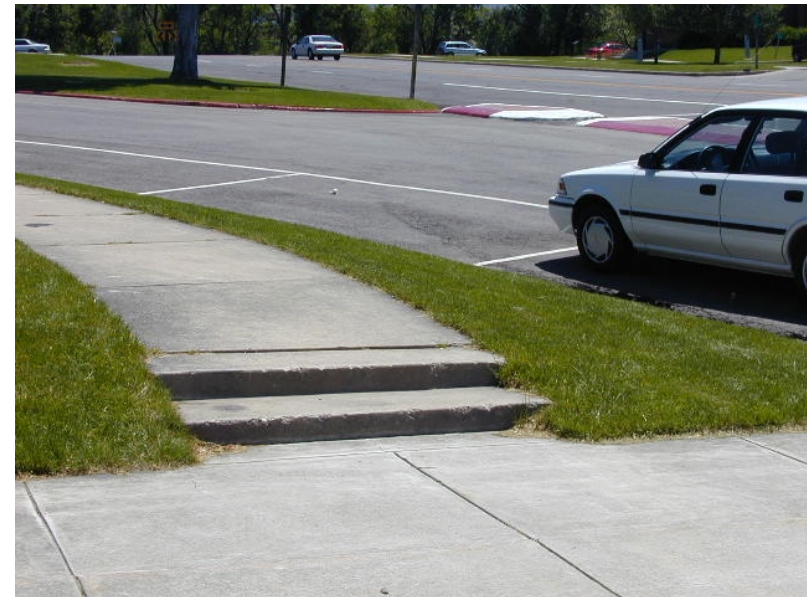
**ID**    **54**

Condition good. Note access across 300 North (pass through to the right ahead of vehicle) has no straight path to sidewalk or ramp (in foreground of photo).

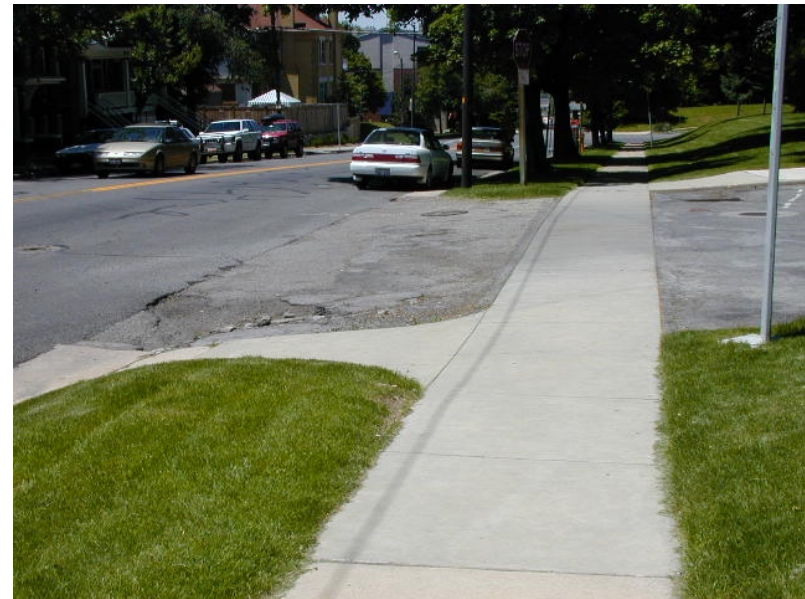
ID 57

Sidewalk condition good. Entrance to parking  
area in poor condition due to drainage problems.

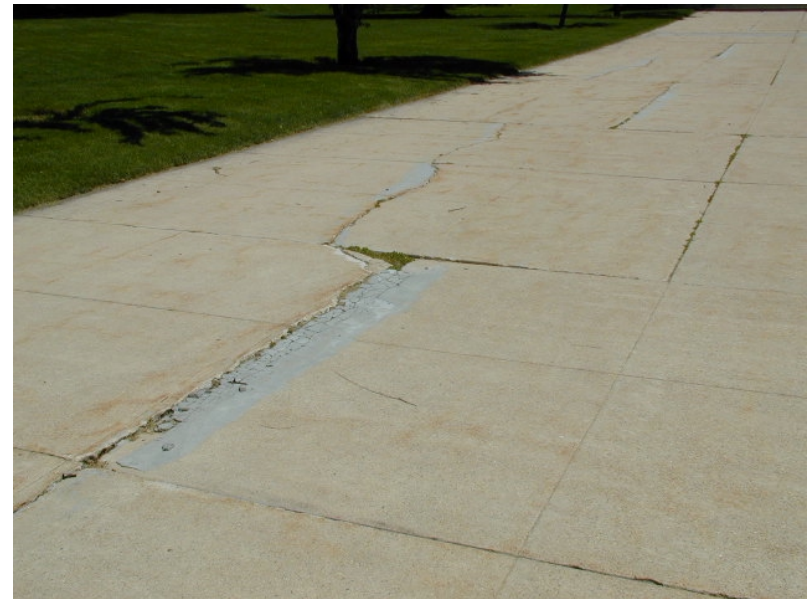
ID 62

**West pedest. entrance to Capitol, at  
Vietnam Mem.**

CO

Cracked, spalled, damaged concrete,  
needs repair or replacement

Some settling, large cracks

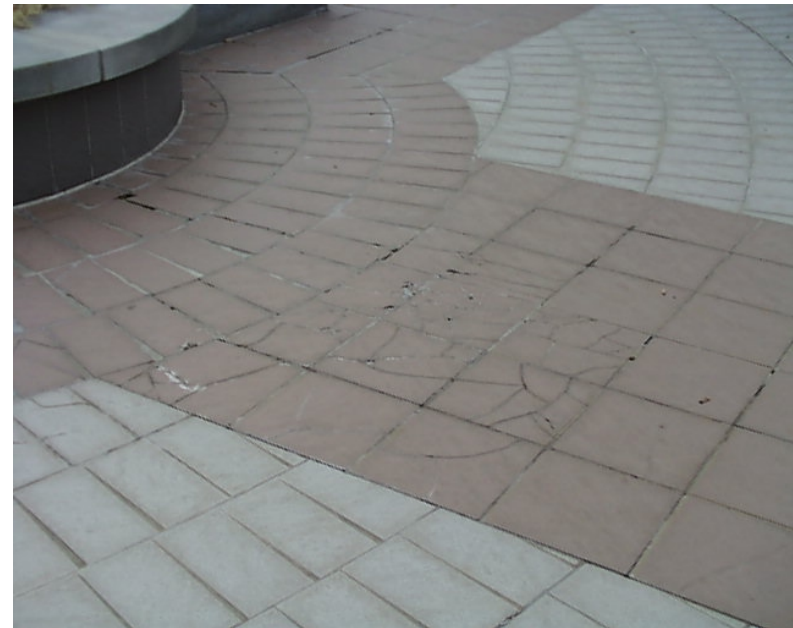
**ID**    **64**

**Interior walkway at Vietnam Memorial**

O

Cracked tiles, loose chips, need repair or replacement

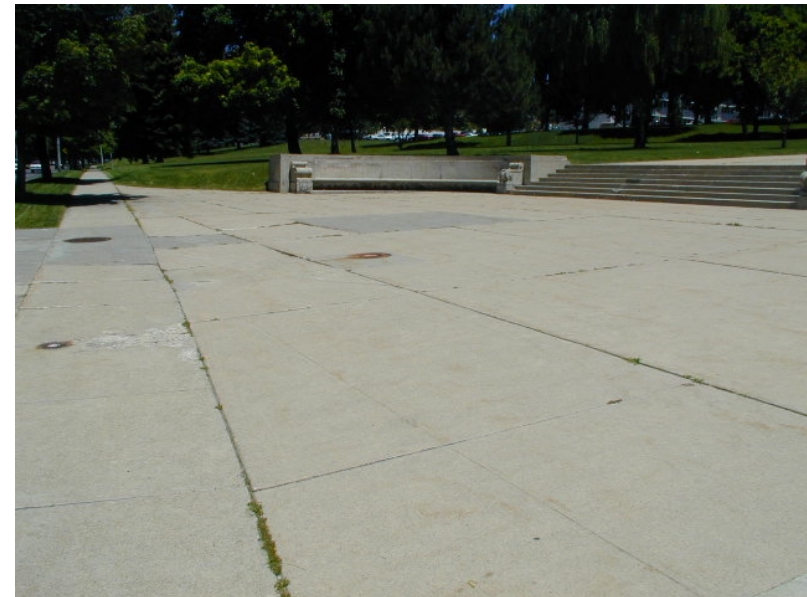
**ID**    **67**

**Location:**                **West entrance at Columbus Street, looking north**

*Condition Code:*        CO

*Condition Description:*    Cracked, spalled, damaged concrete, needs repair or replacement

*Comments:*                Uneven surface for wheelchairs, poor condition for pedestrian entrance to Capitol.

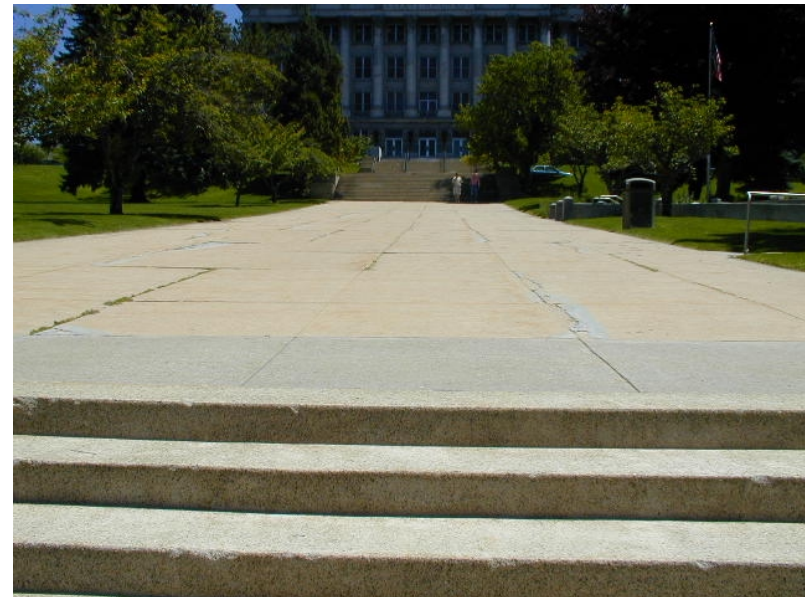
**ID**    **68**

Some settling, different color grout unappealing for large entrance way.

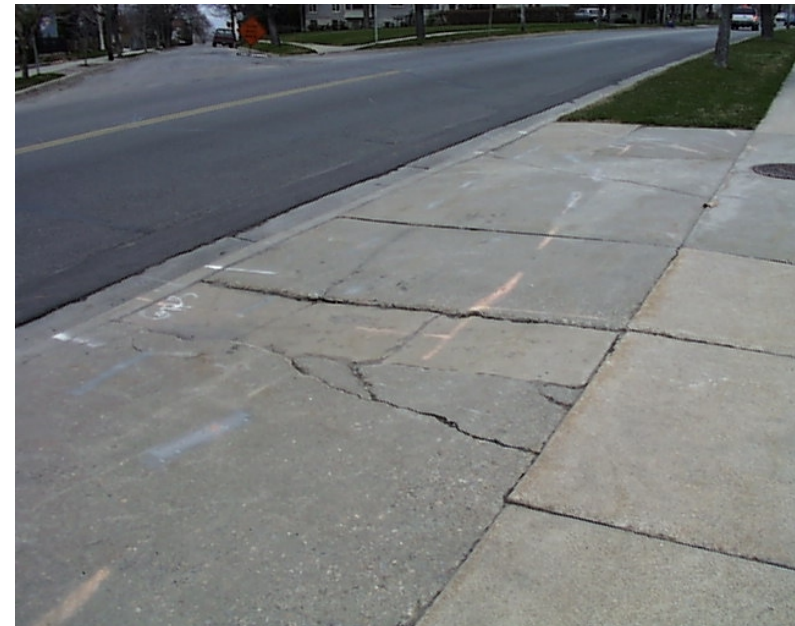
**ID**    **69**

**Category:**                      **Sidewalks**  
**Location:**                      **West pedestrian entrance at Columbus Street**

*Condition Code:*                CO

*Condition Description:*      Cracked, spalled, damaged concrete, needs repair or replacement

*Comments:*                      Severe cracking, unlevel surface

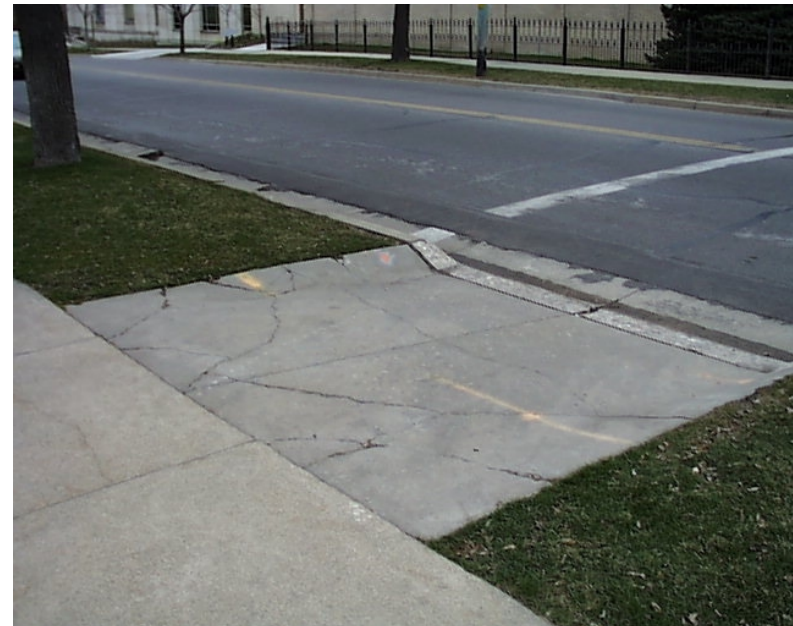
**ID**    **70**

Some cracking, generally smooth for handicap access.

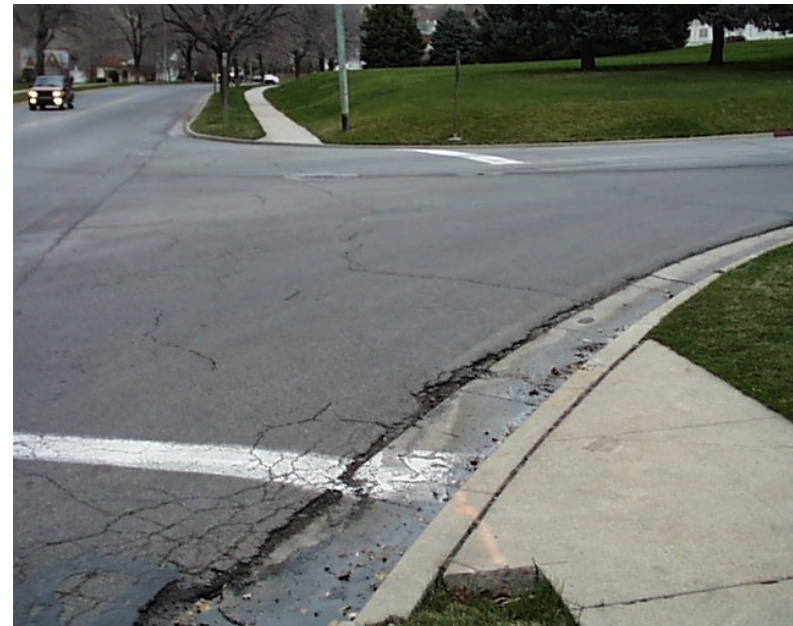
**ID**    **73**

Sidewalk good condition. Note no handicap ramp on either end of sidewalk.
